NL INDUSTRIES/TARACORP SUPERFUND SITE GROUP
Leed Environmental, Inc.
Van Reed Office Plaza
2209 Quarry Drive, Suite C-35
Reading, PA 19609
Telephone: (610) 670-7310
Facsimile: (610) 670-7311

Re: NL Industries/Taracorp Superfund Site; Granite City, Illinois
First 2019 Semi-Annual Operation and Maintenance Inspection (May 2019)

Inspection Date: 5/20/2019

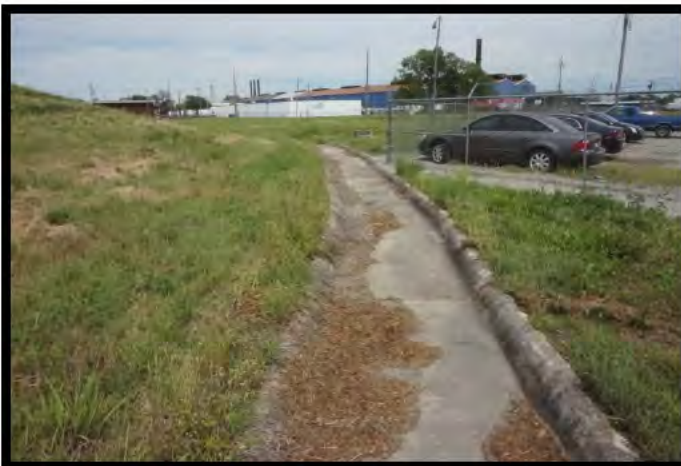
Photograph 47: Vegetation and concrete drainage swale along southern slope of Taracorp cap pile.

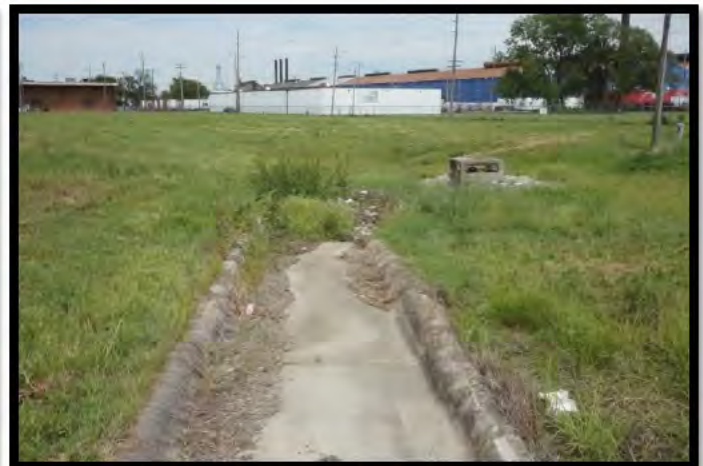
Photograph 48: Concrete drainage swale along southern slope of Taracorp pile.

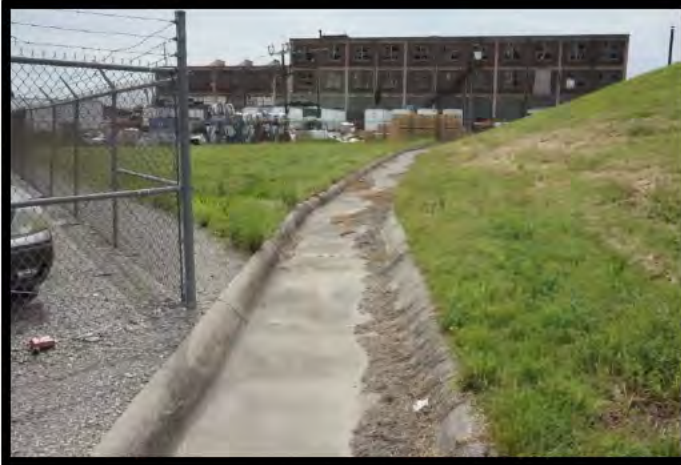
Photograph 49: Concrete drainage swale along southern slope of Taracorp pile.

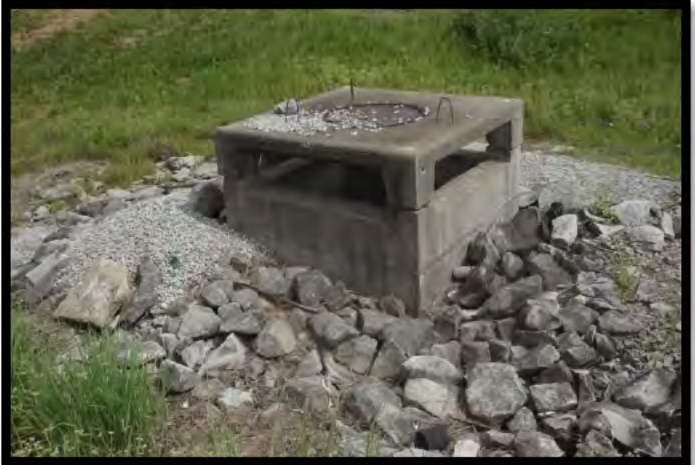
Photograph 50: Southern side of Taracorp pile, stormwater outlet.

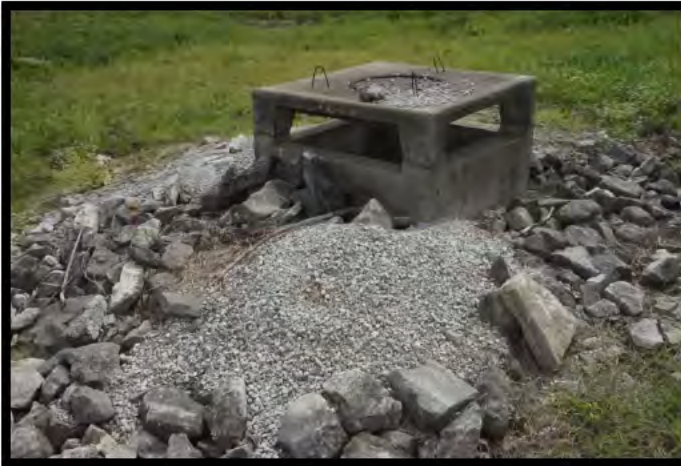
Photograph 51: Stormwater outlet.

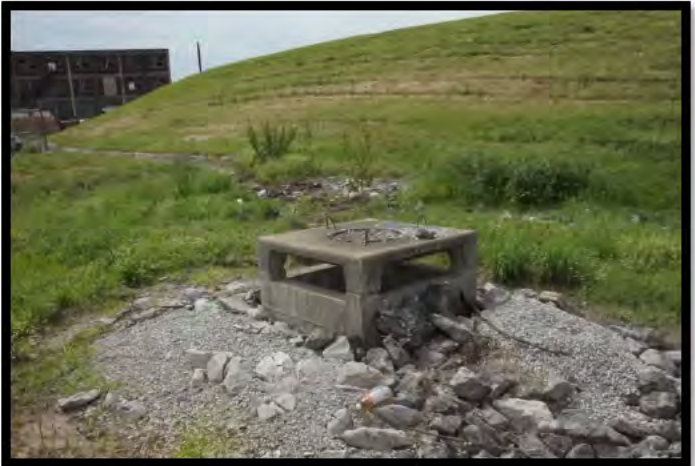
Photograph 52: Stormwater outlet.

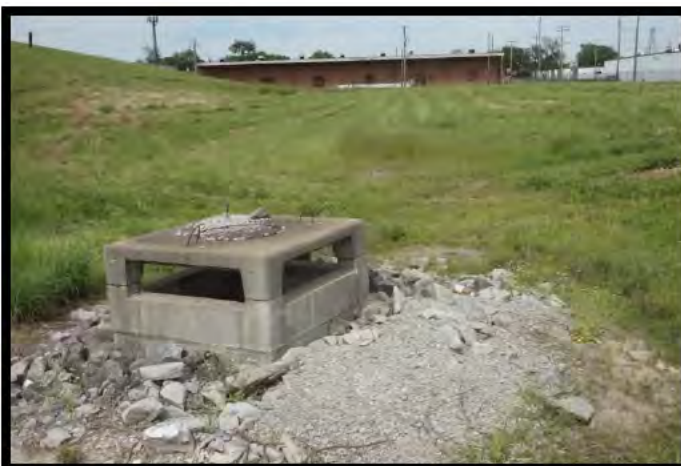
Photograph 53: Stormwater outlet and stormwater retention basin (view northeast).

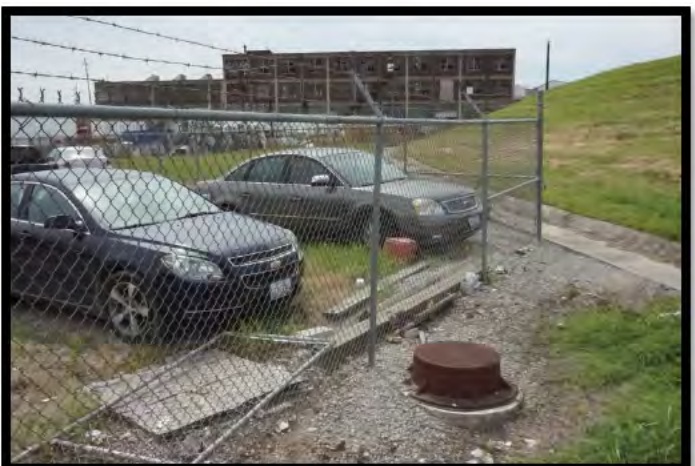
Photograph 54: Stormwater manhole.

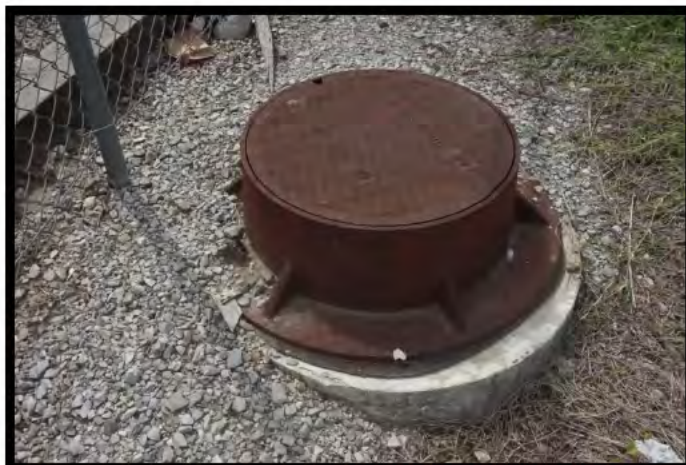
Photograph 55: Stormwater manhole near fence.

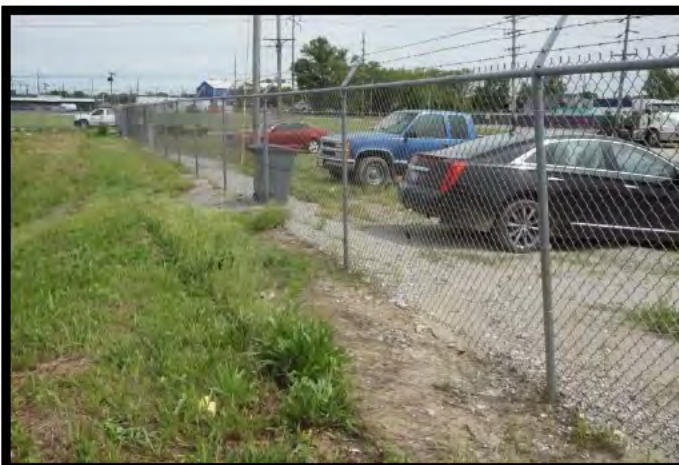
Photograph 56: Vegetation and fence near former Rich Oil facility (view toward State Street).

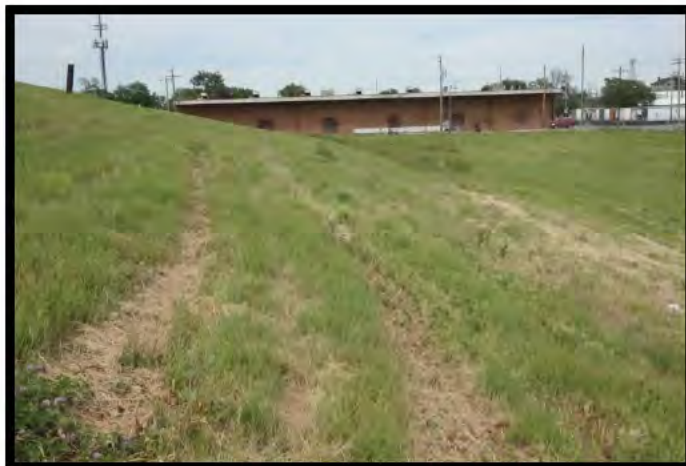
Photograph 57: Vegetation, eastern side of Taracorp pile cap.

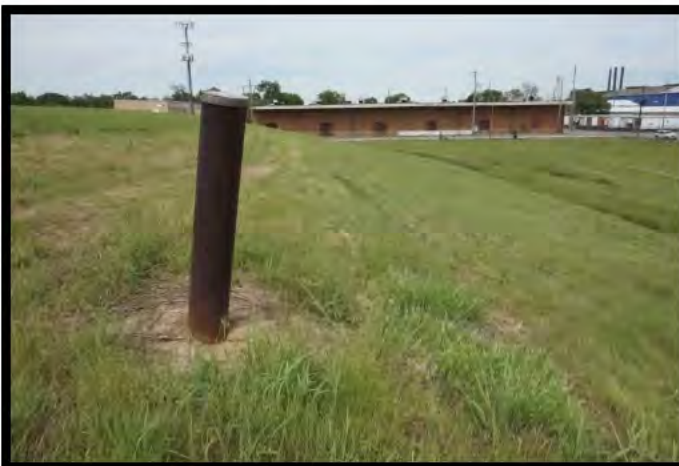
Riser pipe - evidence of deterioration	Yes	No		
Riser pipe - locked	Yes	No		
Leachate levels in sump	No	---		
Comments			No problems identified. Leachate level checked during five-year review site work.	
Concrete Drainage Channel Around Taracorp Pile				
Evidence of cracks or other deterioration	Yes	Yes	Some cracks observed in concrete drainage channel (probably from mowing). No evidence of adverse impacts to surface water drainage.	
Evidence of obstructions	Yes	No		
Evidence of erosion	Yes	No		
Evidence of improper drainage	Yes	No		
Comments				
Retention Basin for Stormwater Runoff				
Adequate vegetation	Yes	No		
Evidence of erosion or deterioration	Yes	No		
Appropriate drainage to storm sewer	Yes	No		
Comments			No problems with retention basin evident.	
Concrete Sidewalk (1555 State Street Property)				
Evidence of cracks or other deterioration	Yes	No		
Comments			Concrete sidewalk is in good condition; no problems identified.

Photograph 58: Leachate riser pipe.

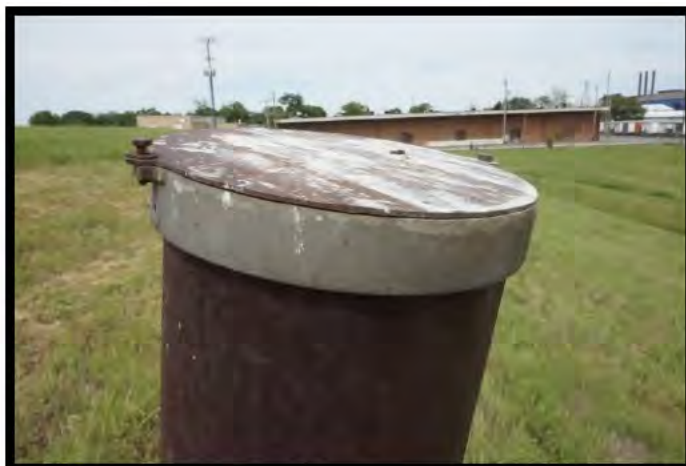
Photograph 59: Locked lid on leachate riser pipe (locked lid installed fall 2007).

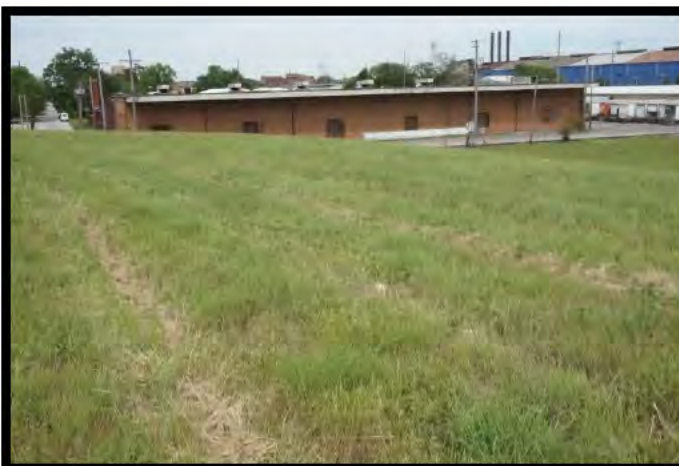
Photograph 60: Vegetation, top of Taracorp pile (view northeast).

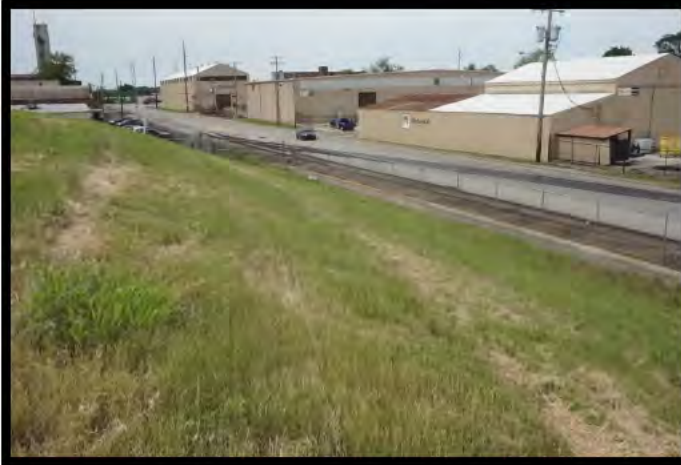
Photograph 61: Vegetation, top of Taracorp pile (view northwest).

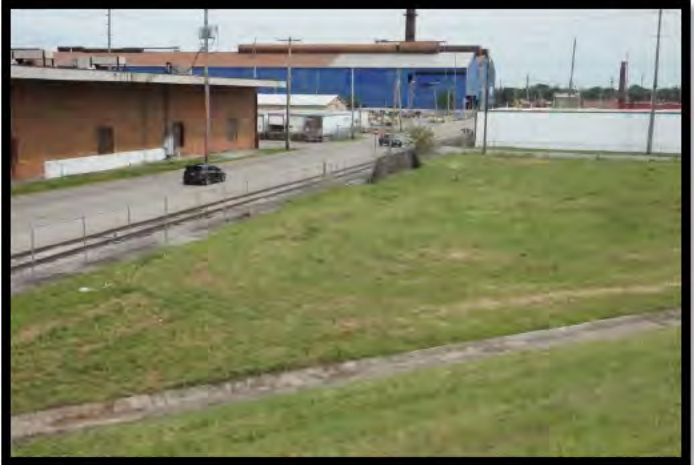
Photograph 62: Vegetation, former BV&G Truck Service area.

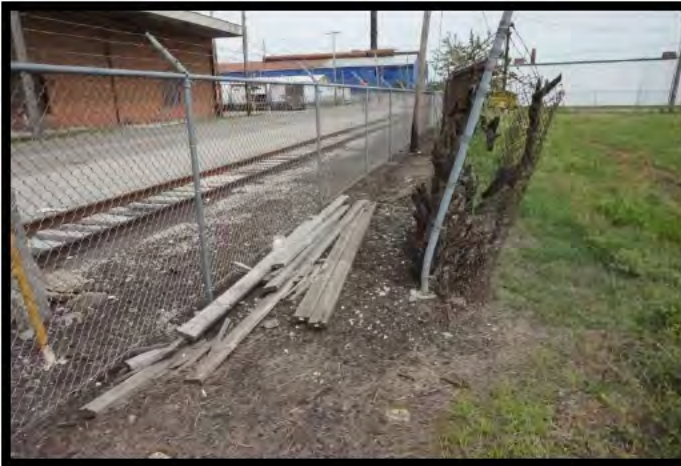
Photograph 63: Older and newer fence near former BV&G Truck Service buildings and along railroad tracks (view northeast).

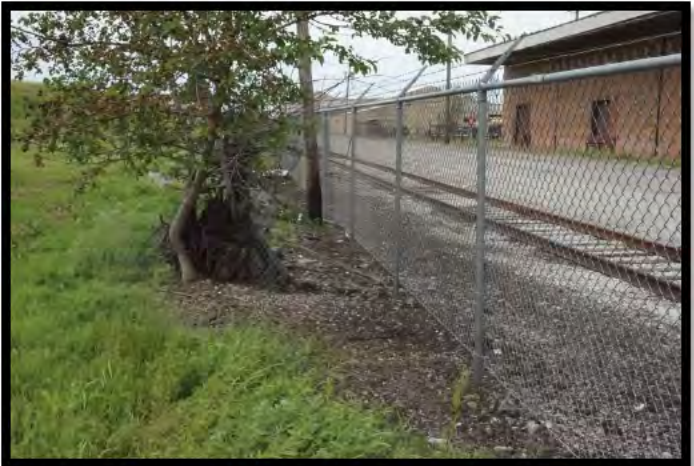
Photograph 64: Older and newer fence near former BV&G Truck Service buildings and along railroad tracks (view northwest).

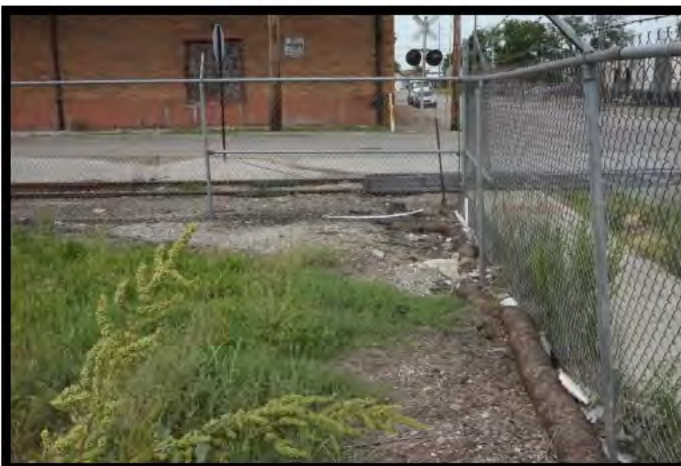
Photograph 65: Inside fence, corner of State Street and 16th Street.

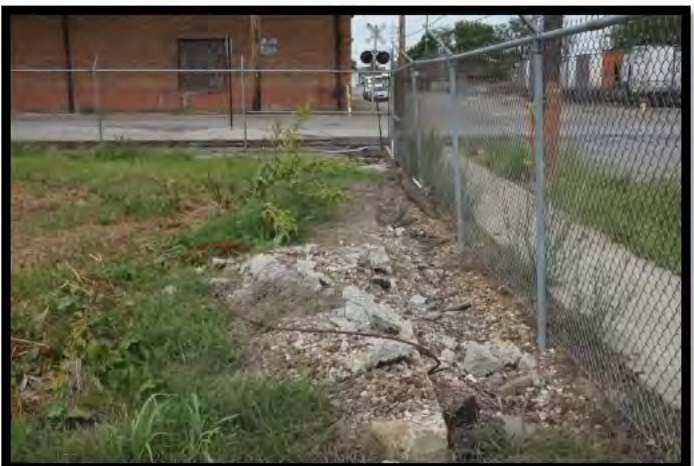
Photograph 66: Inside fence, corner of State Street and 16th Street.

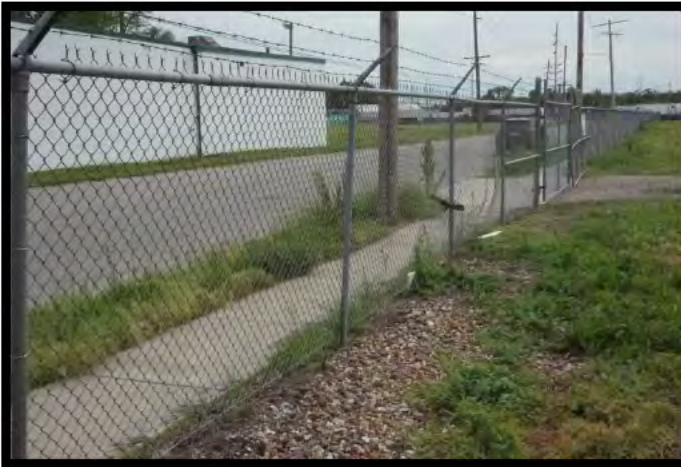
Photograph 67: Inside fence, corner of State Street and 16th Street.

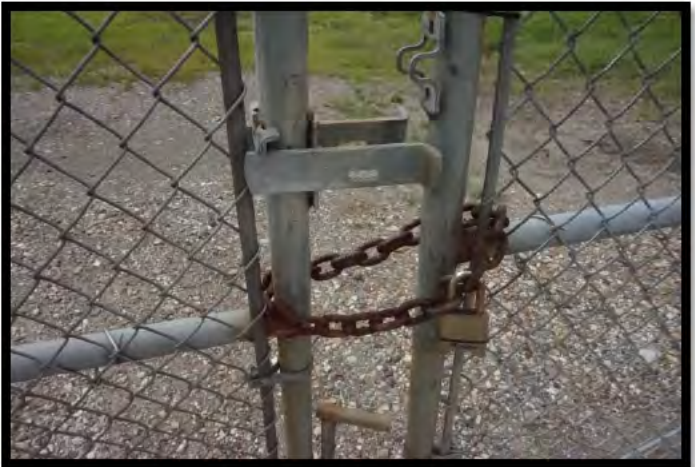
Photograph 68: Lock on State Street gate.

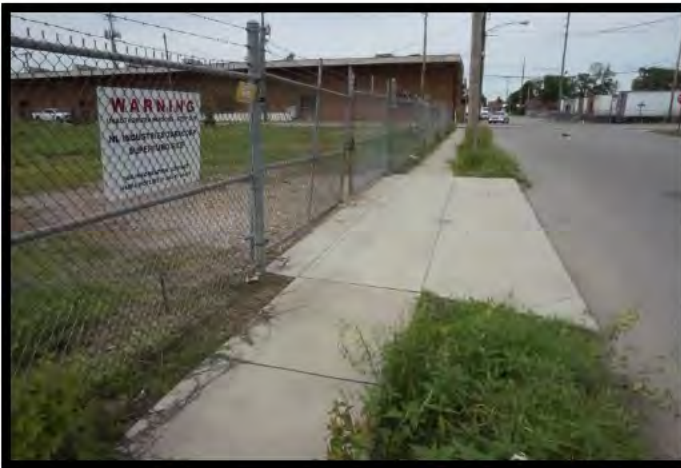
Photograph 69: Concrete entranceway gate near 16th Street and State Street.

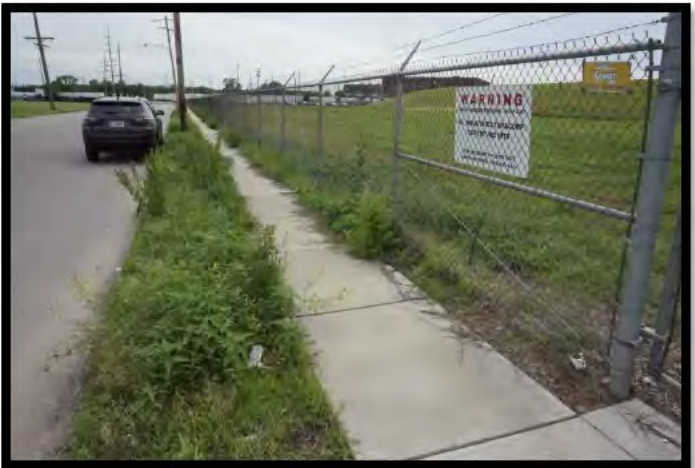
Photograph 70: Fence, warning sign, grass, and sidewalk along State Street.

Evidence of rust, cuts, deterioration, or other damage	Yes	No		
Evidence of tampering	Yes	No		
Securely affixed to fence	Yes	Yes	Warning sign on northwestern side of Taracorp pile was not attached to the fence.	The Group requested a proposal from TNT Fence Company to reaffix the sign and to check wire ties for other warning signs.
Signs legible	Yes	No		
Comments				
Access Road				
Evidence of settlement or deterioration	Yes	No		
Comments			No access road problems.	
Taracorp Pile - Vegetation				
Adequate growth of vegetation	Yes	No		
Adequate diversity of vegetation	Yes	No		
Evidence of stress	Yes	No	No stress; thick vegetation.	
Presence of trees, shrubs, woody bushes	Yes	No	No trees, shrubs, etc. observed.	
Need for mowing/maintenance	Yes	No		
Comments			The Group's contractor, Munie Greencare Professionals (Munie), cut the vegetation on the flat parts of 1555 State Street property and the Taracorp pile cap on May 17, 2019.	Following the inspection, the Group requested that Munie cut the vegetation along the State Street sidewalk.

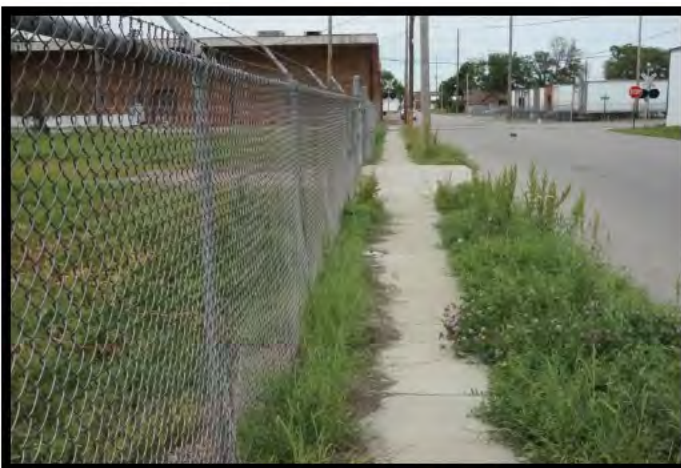
Photograph 71: Fence, grass, and sidewalk along State Street.

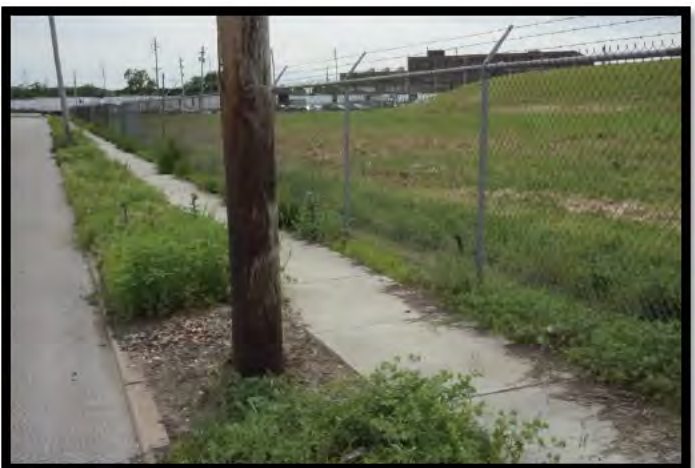
Photograph 72: Fence, grass, utility pole, and sidewalk along State Street.

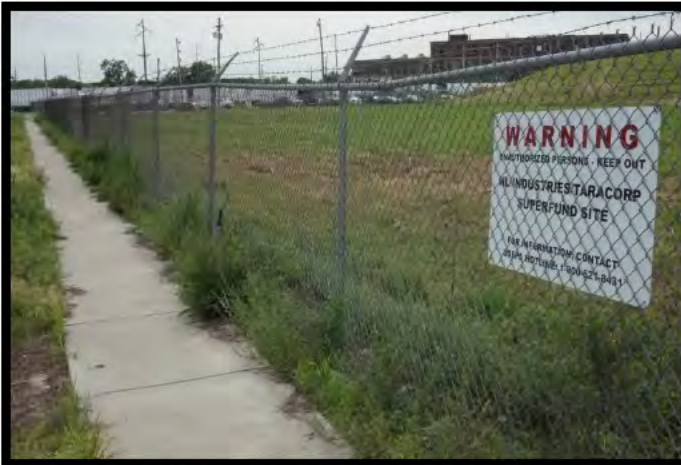
Photograph 73: Warning sign along State Street.

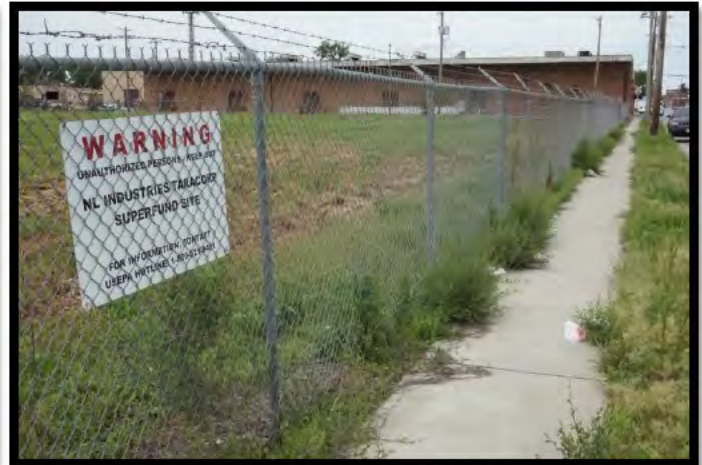
Photograph 74: Warning sign along State Street.

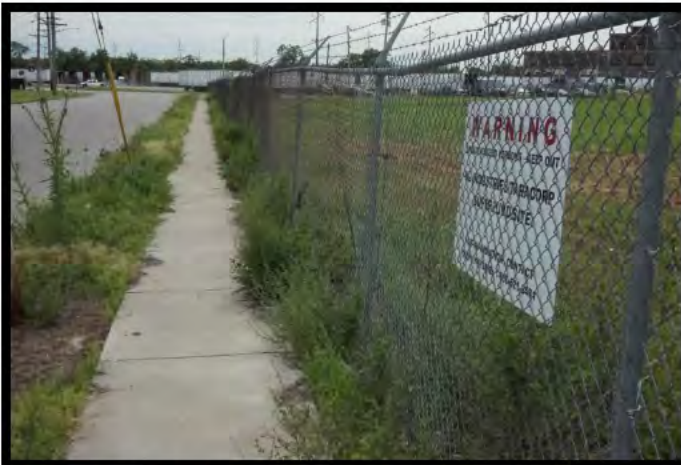
Photograph 75: Warning sign along State Street.

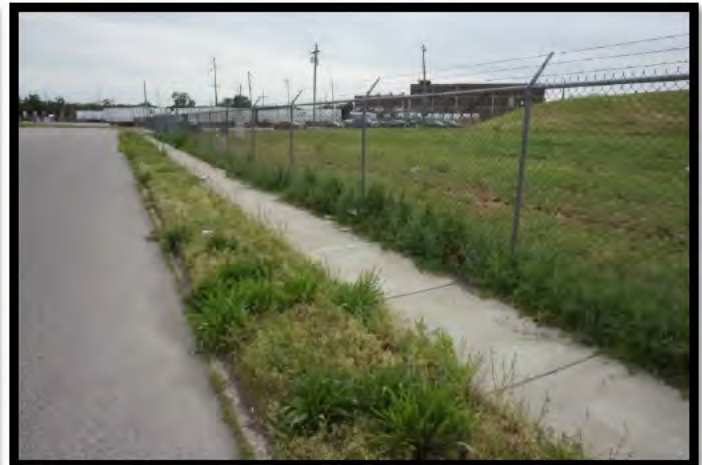
Photograph 76: Sidewalk along State Street.

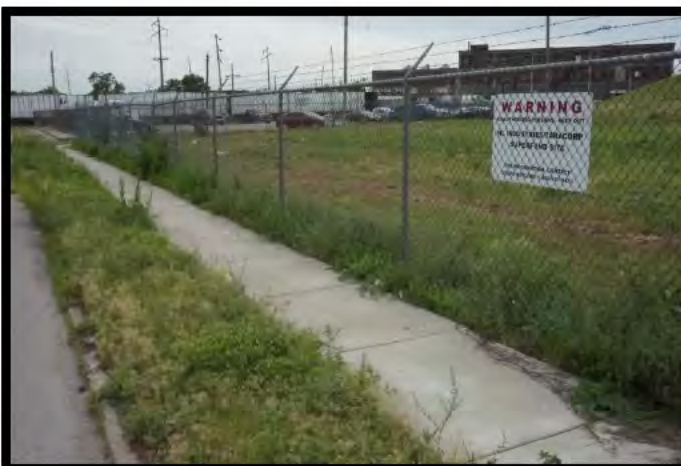
Photograph 77: Sidewalk along State Street.

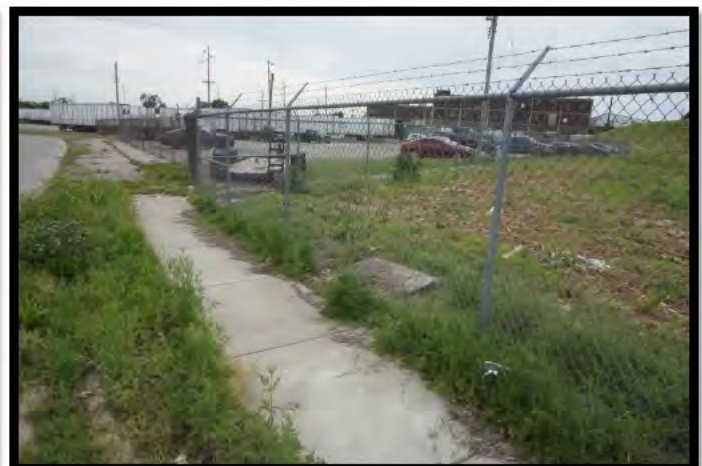
Photograph 78: Southern end of concrete sidewalk on 1555 State Street property (adjacent to former Rich Oil property).

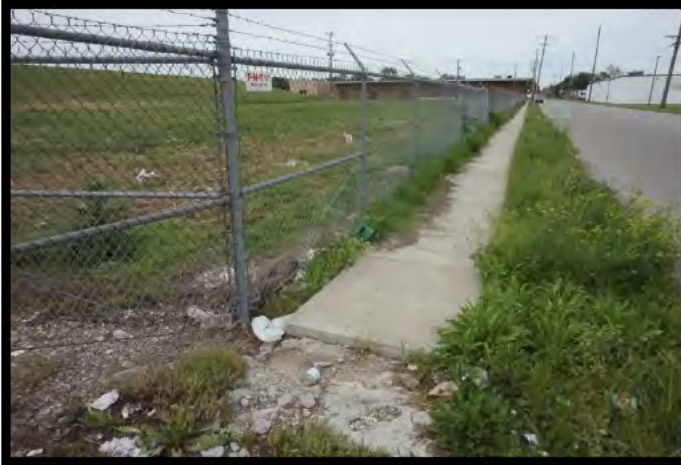
Photograph 79: Southern end of concrete sidewalk on 1555 State Street property (adjacent to former Rich Oil property).

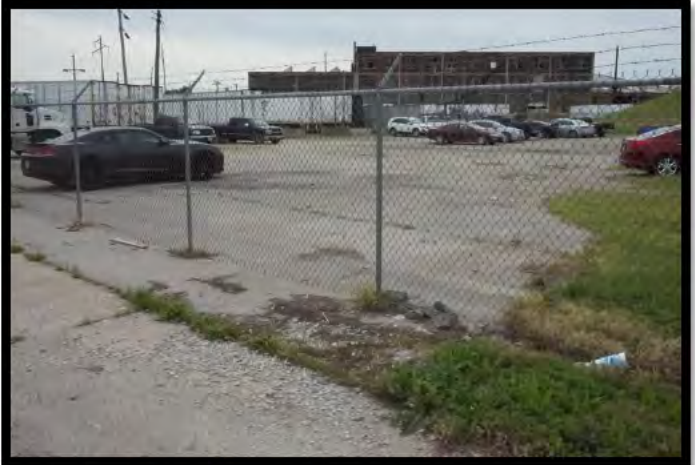
Photograph 80: Former Rich Oil property.

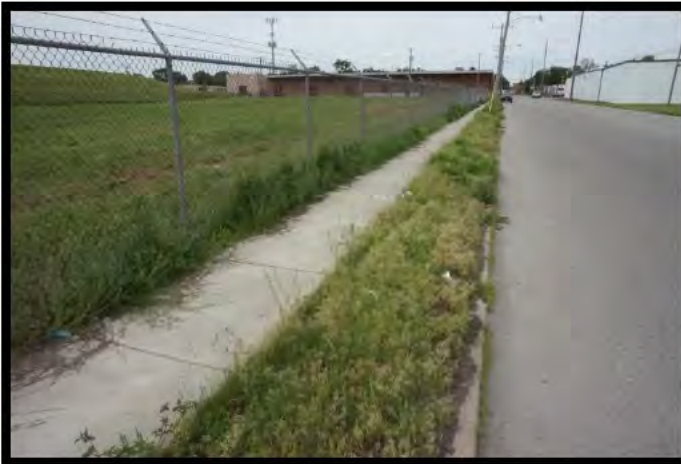
Photograph 81: Fence, grass, and sidewalk along State Street.

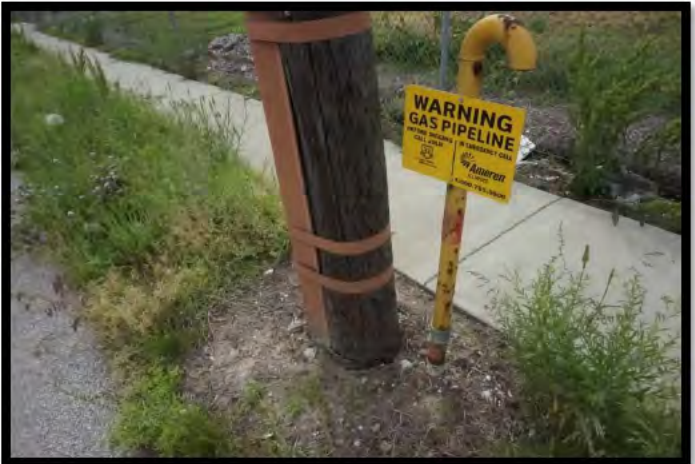
Photograph 82: Utility pole near intersection of 16th Street and State Street.

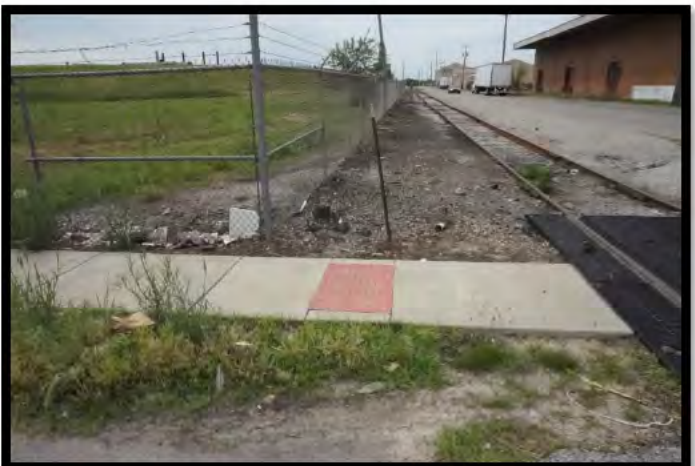
Photograph 84: End of sidewalk along railroad tracks.

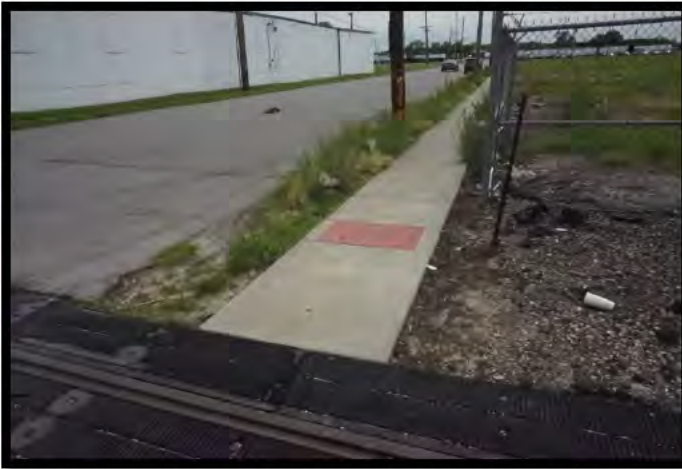
Photograph 85: End of sidewalk along railroad tracks.

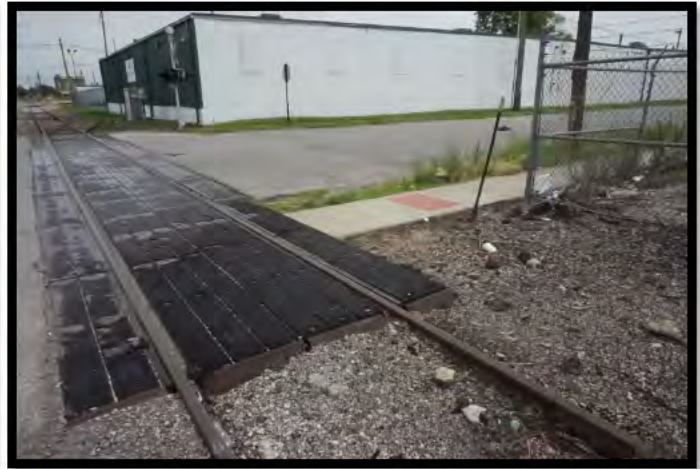
Photograph 86: End of sidewalk along railroad tracks.

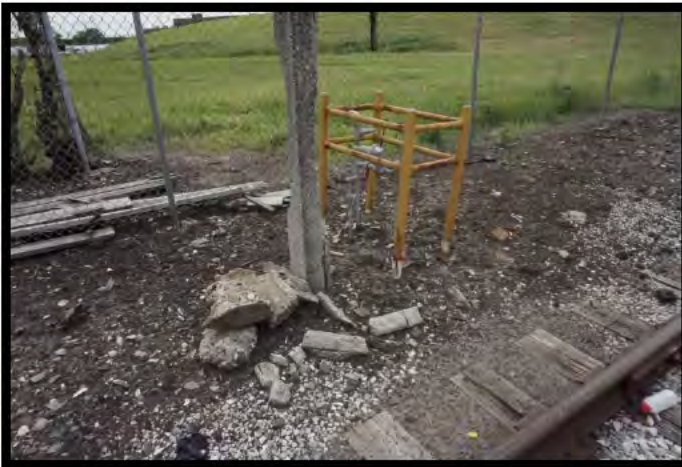
Photograph 87: Gas utilities along railroad tracks.

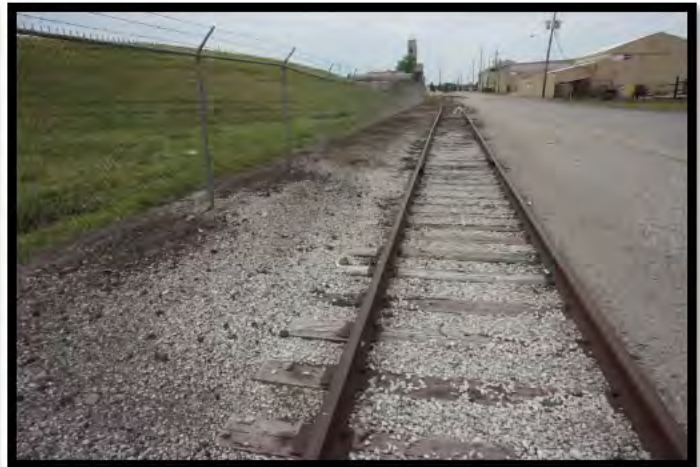
Photograph 88: Fence along railroad tracks and 16th Street.

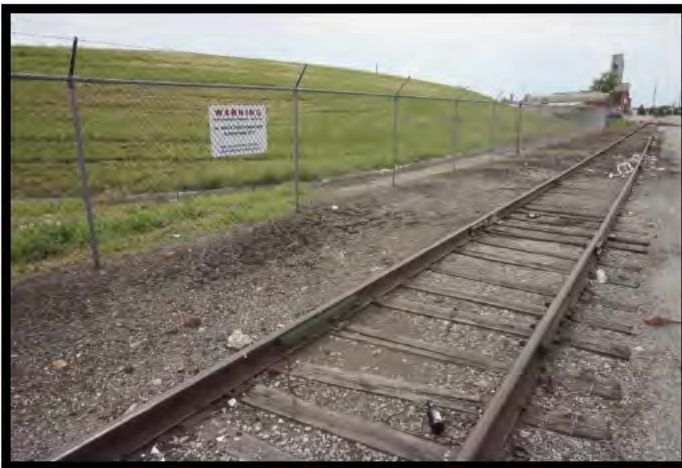
Photograph 89: Warning sign on fence along railroad tracks near 16th Street and Edison Avenue.

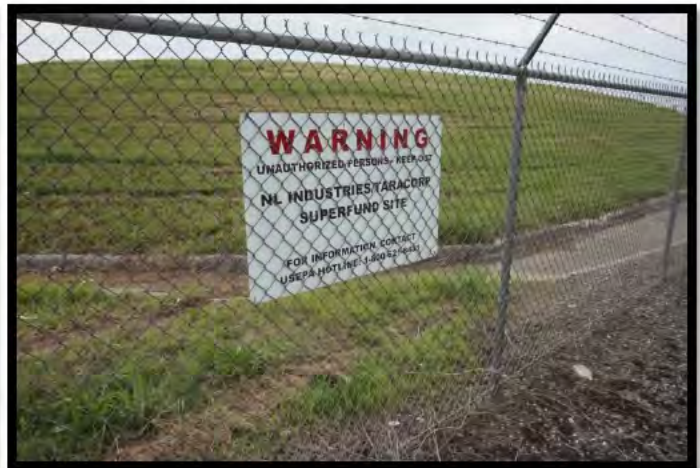
Photograph 90: Warning sign on fence along railroad tracks near 16th Street and Edison Avenue.

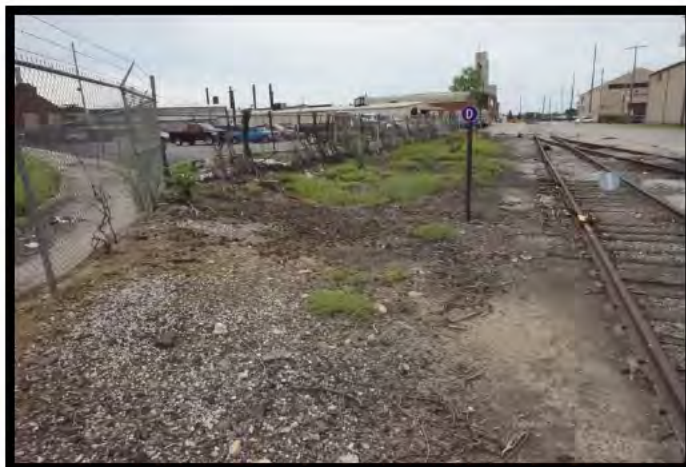
Photograph 91: Fence and vegetation along railroad tracks and 16th Street.

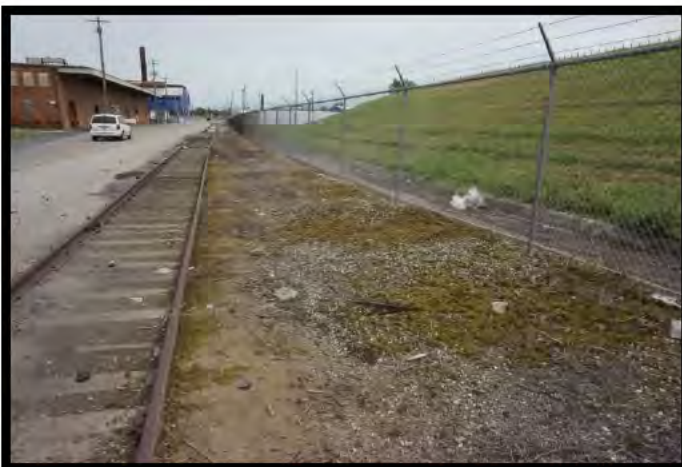
Photograph 92: Fence and vegetation along railroad tracks and 16th Street.

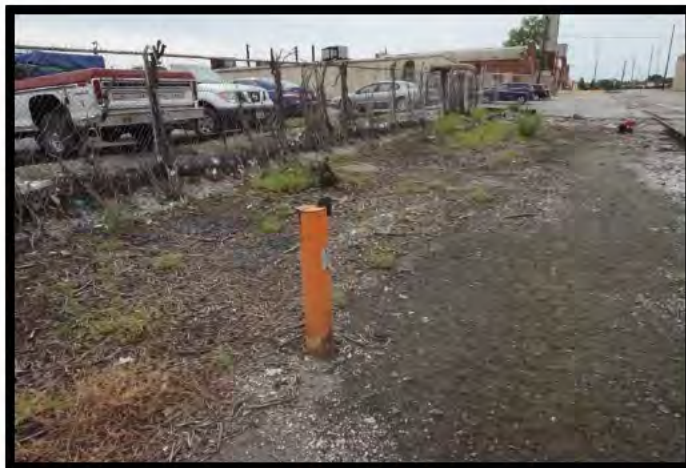
Photograph 93: Monitoring well, fence, and vegetation along railroad tracks and 16th Street.

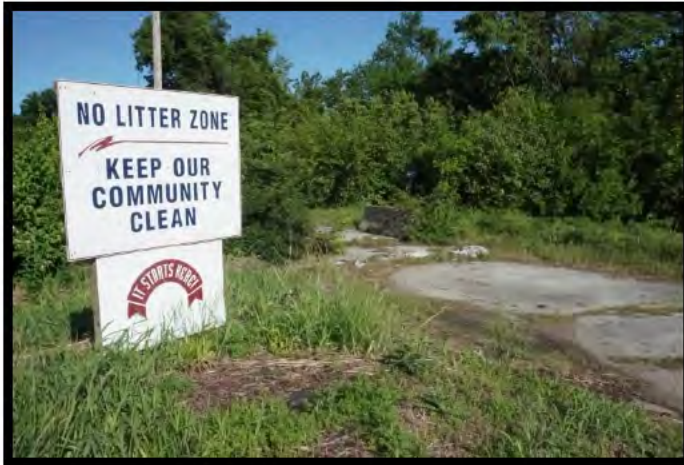
Photograph 1: Schaeffer Road property, entrance.

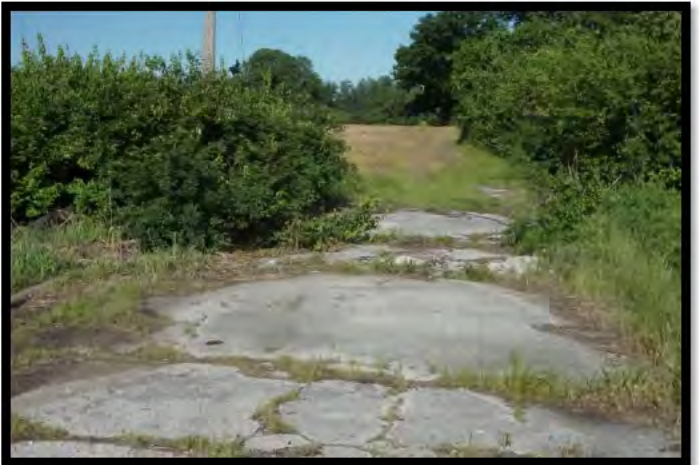
Photograph 2: Schaeffer Road property, entrance.

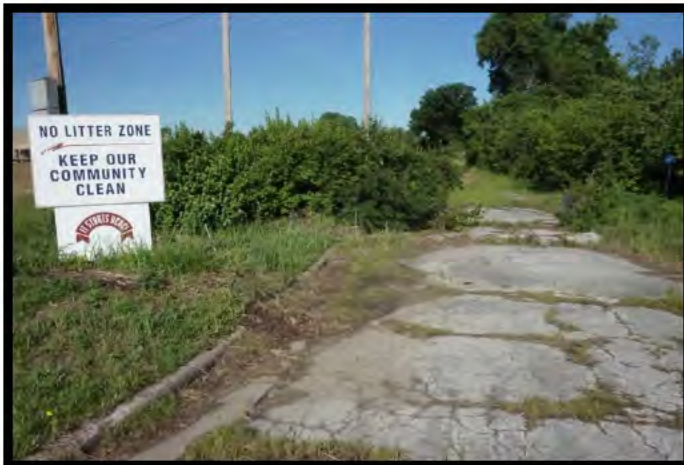
Photograph 3: Schaeffer Road property, entrance.

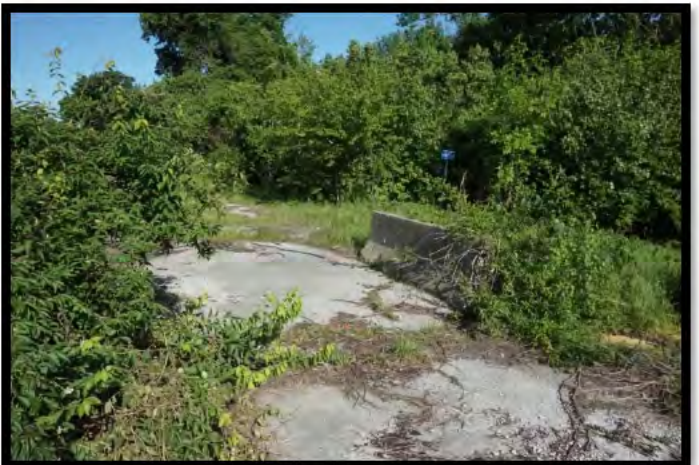
Photograph 4: Schaeffer Road property, entrance.

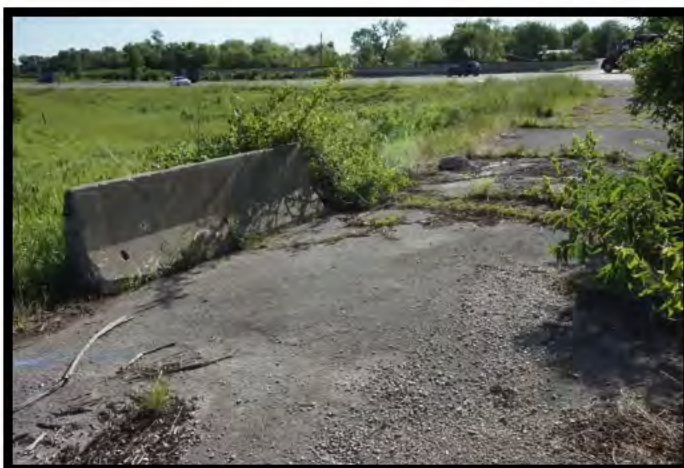
Photograph 5: Schaeffer Road property, entrance.

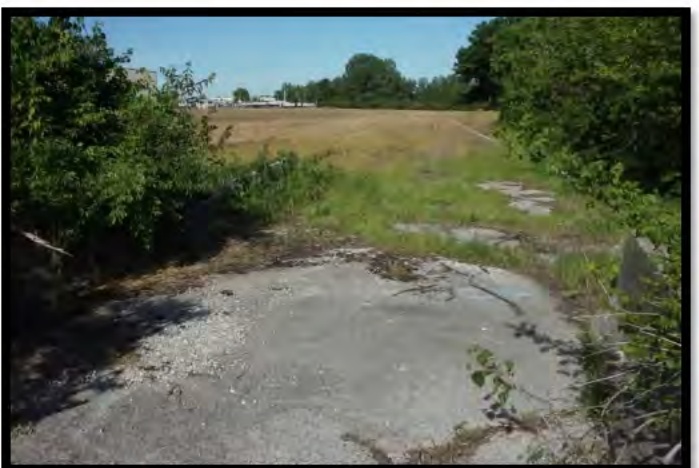
Photograph 6: Schaeffer Road property, entrance.

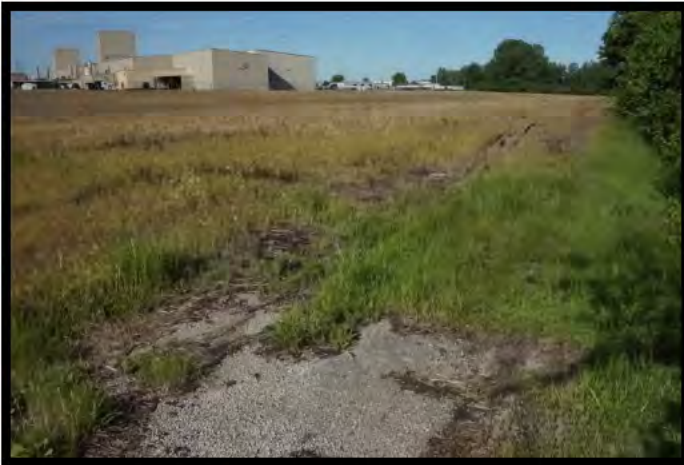
Photograph 7: Schaeffer Road property, roadway.

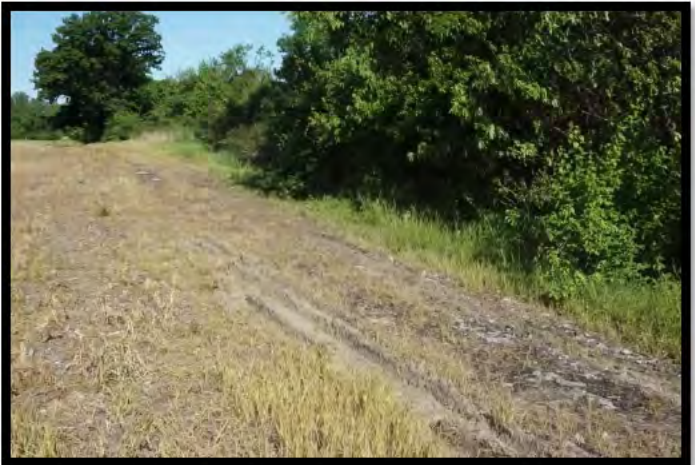
Photograph 8: Schaeffer Road property, roadway.

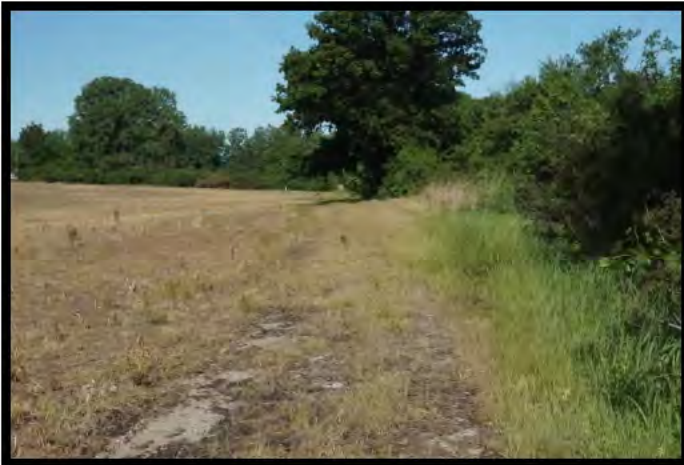
Photograph 9: Schaeffer Road property, roadway.

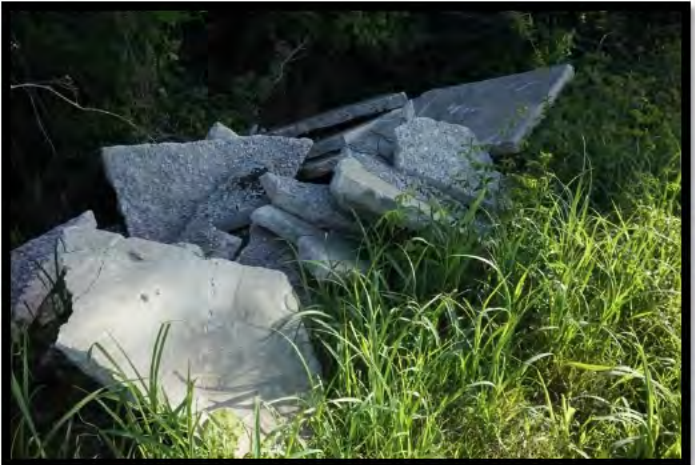
Photograph 10: Schaeffer Road property, concrete debris along roadway.

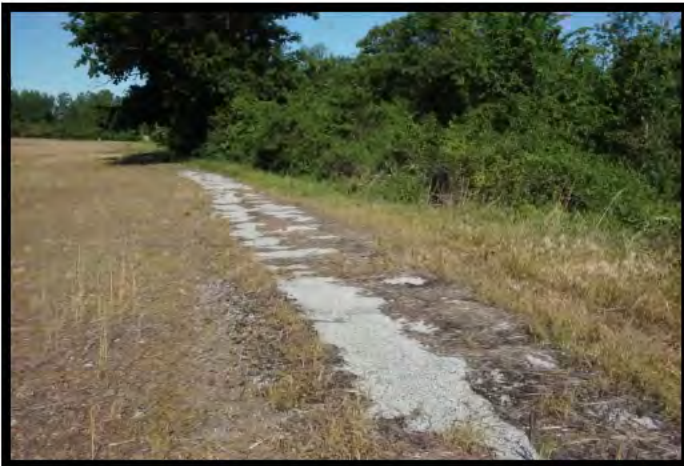
Photograph 11: Schaeffer Road property, roadway.

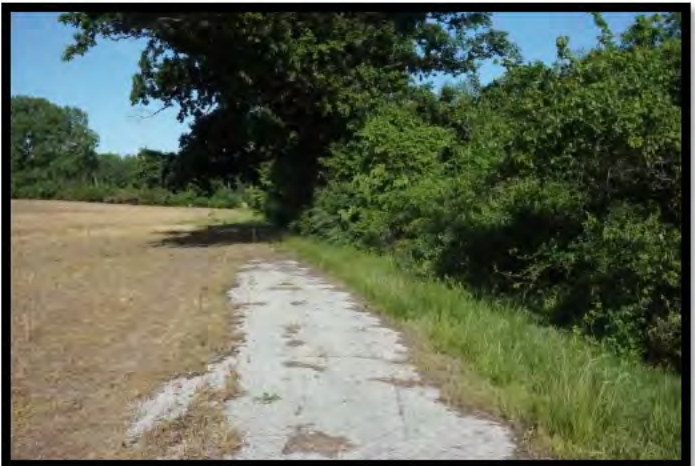
Photograph 12: Schaeffer Road property, roadway.

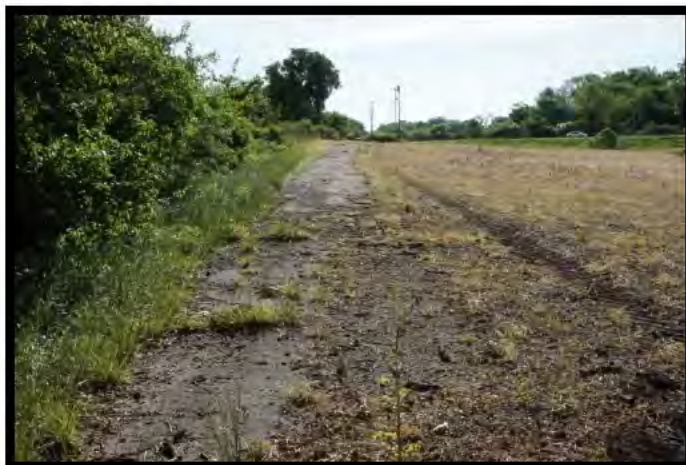
Photograph 13: Schaeffer Road property, roadway.

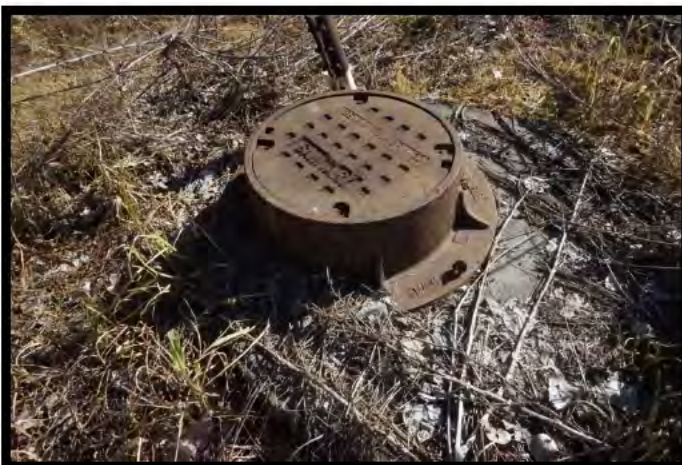
Photograph 14: Schaeffer Road property, sanitary sewer manhole.

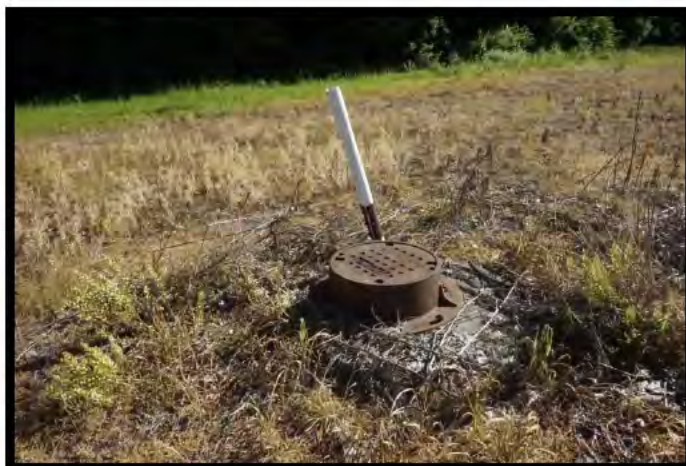
Photograph 15: Schaeffer Road property, sanitary sewer manhole.

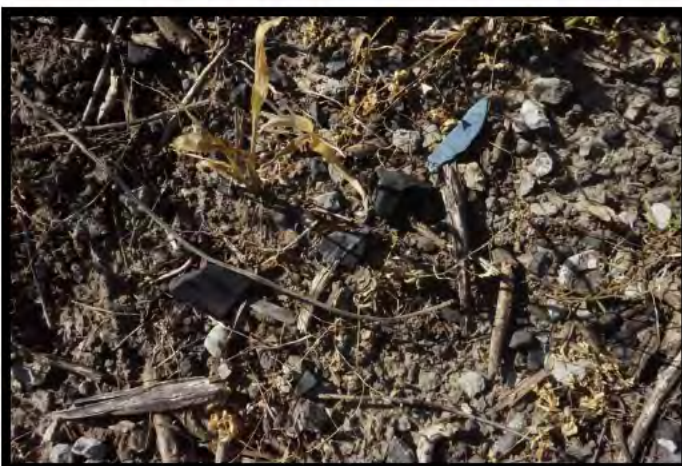
5. Remote fill properties (Schaeffer Road and Sand Road) previously remediated by EPA (and where lead-impacted soil and/or battery case chips may remain in place at a depth of three feet below ground surface) were observed during the inspection. Photographs are provided in Attachment 6 and Attachment 7, respectively. At Schaeffer Road, several scattered battery case chips were observed on the soil surface near the sanitary sewer manhole near the west end of Schaeffer Road at the approximate location shown on Figure 5. Scattered battery case chips and some other debris (bricks, etc.) are evident near the foundation area of the former building at the Sand Road property shown on Figure 6.

Photograph 16: Schaeffer Road property, scattered battery case chips near sanitary sewer manhole.

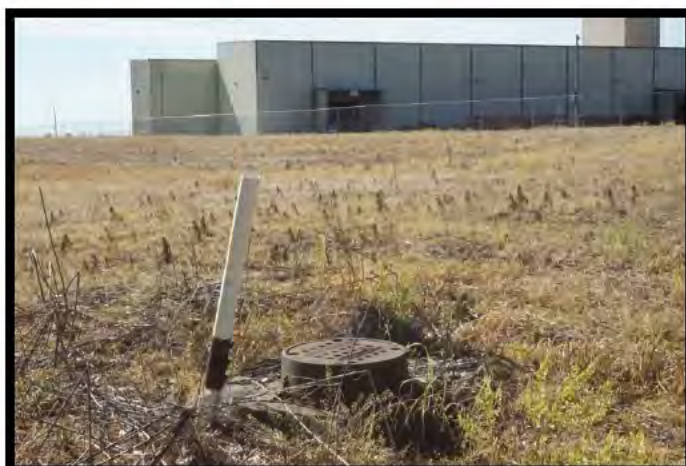
Photograph 17: Schaeffer Road property, sanitary sewer manhole.

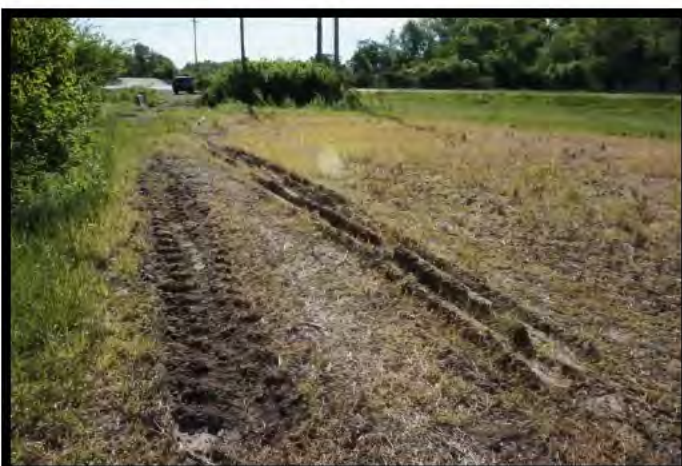
Photograph 18: Schaeffer Road property, roadway.

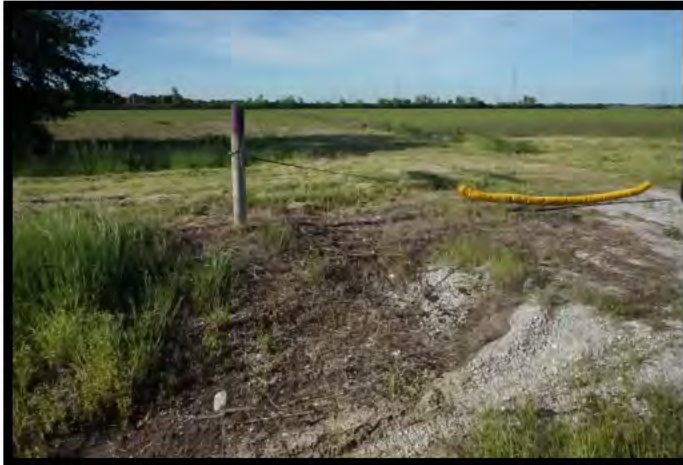
Photograph 1: Sand Road property (view from entrance).

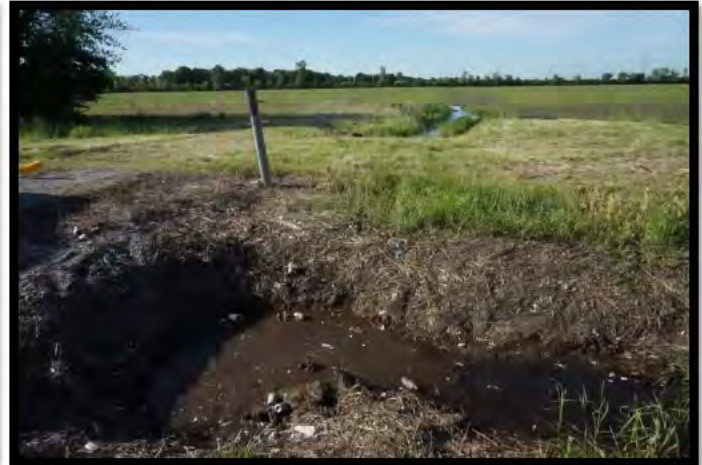
Photograph 2: Sand Road property (view from entrance).
